KOP 1 Viewshed and Visual Simulations

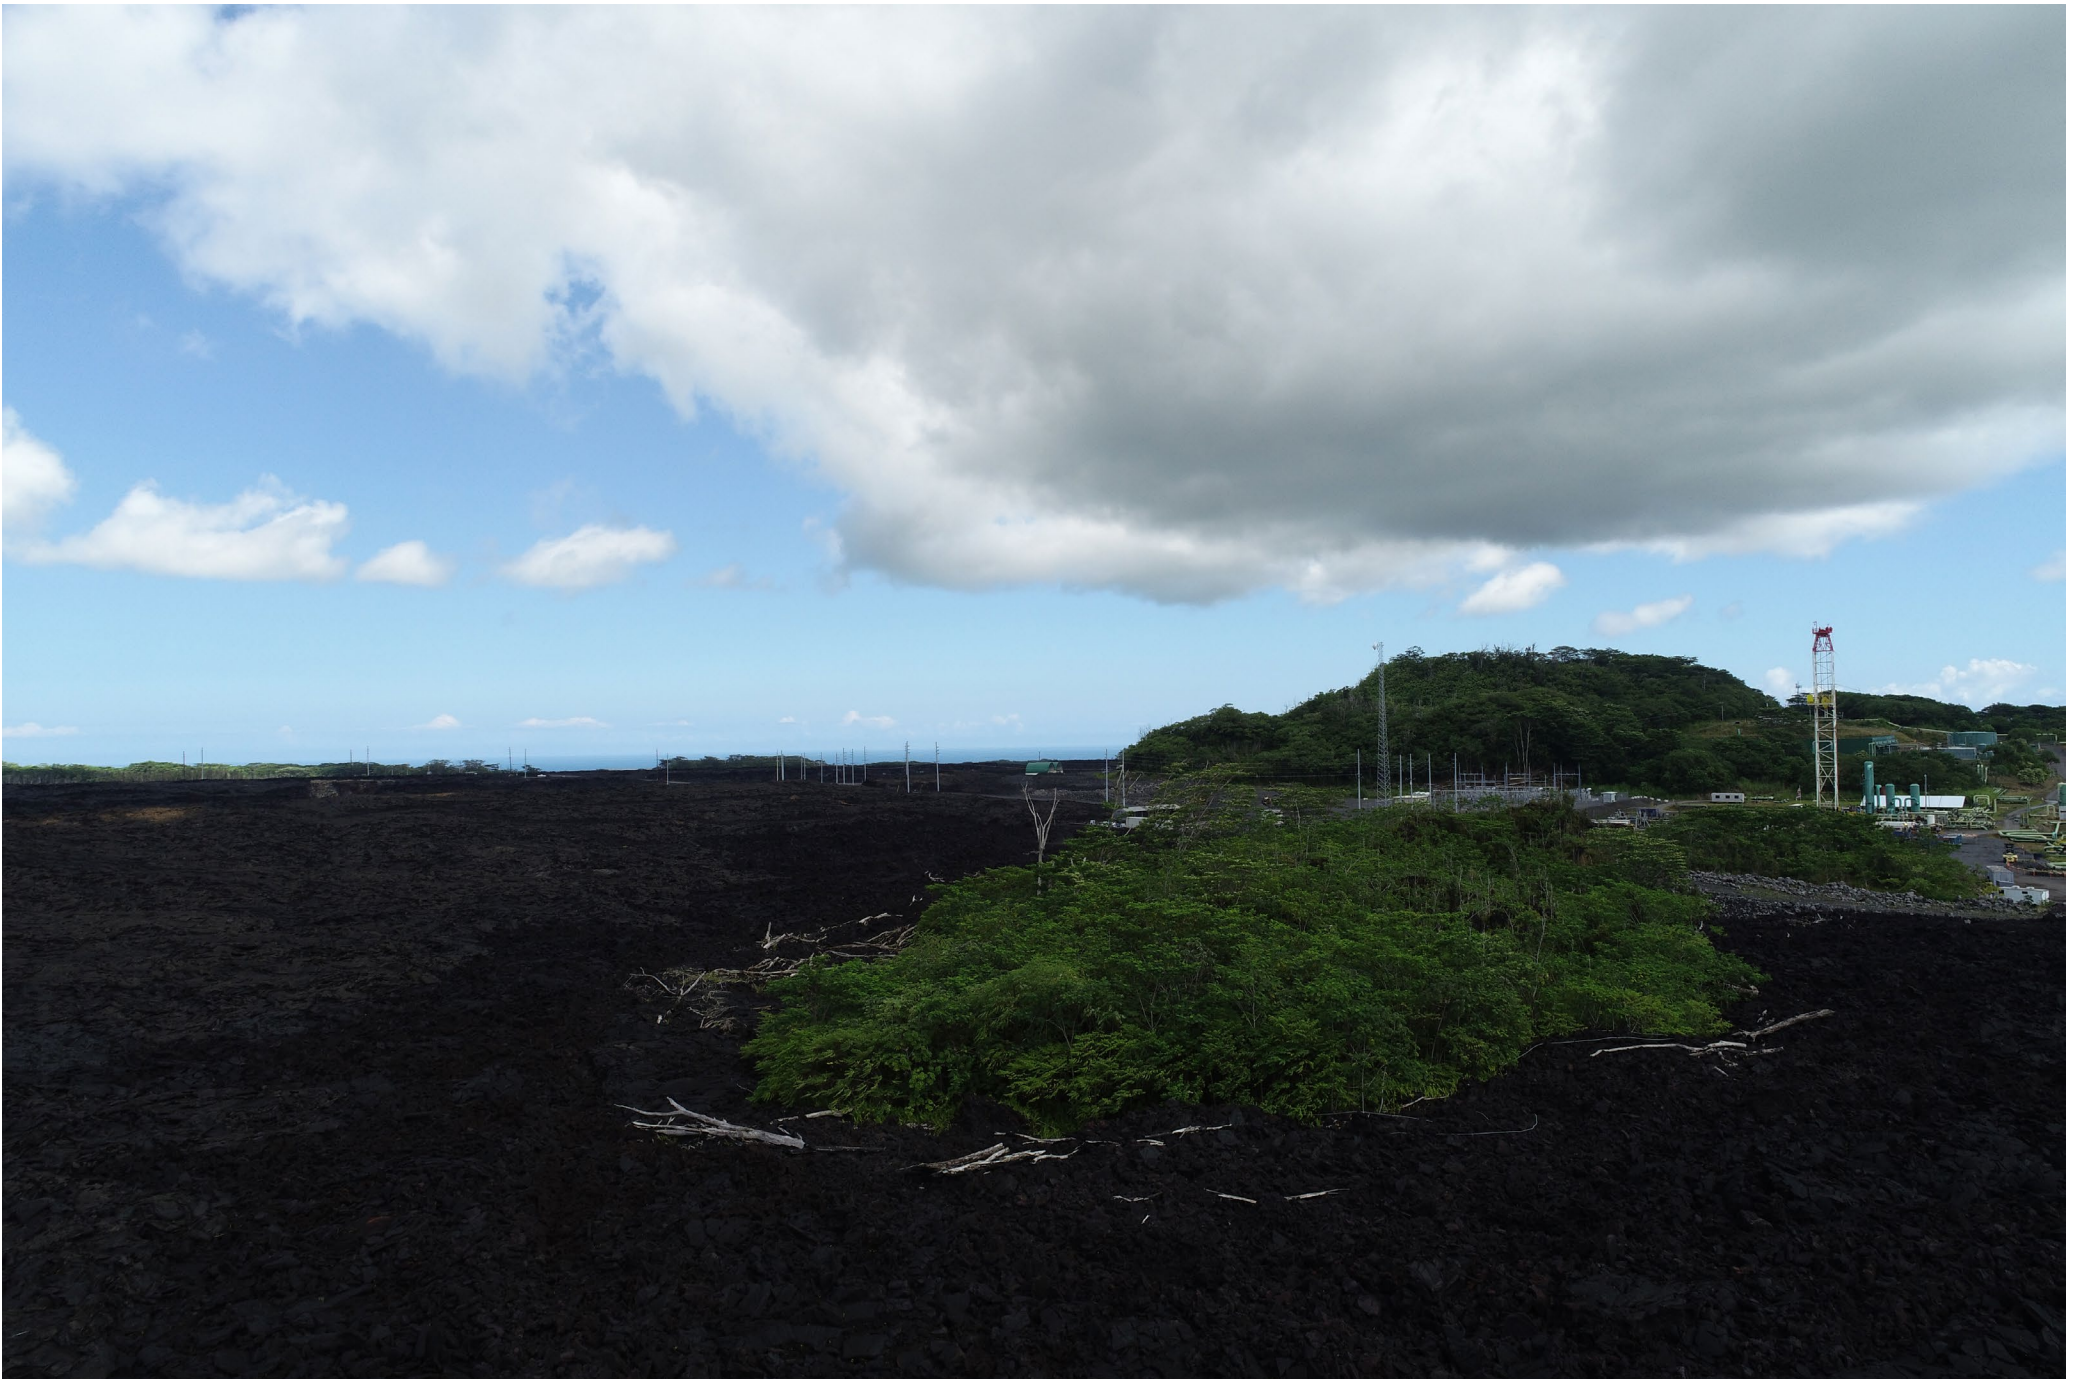
View to the north-northeast from a point above the path of Pāhoa-Pohoiki Road, which was destroyed during the 2018 Lower Puna eruption. Existing OECs are visible in the right portion of the view, as close as 1/3-mile away.

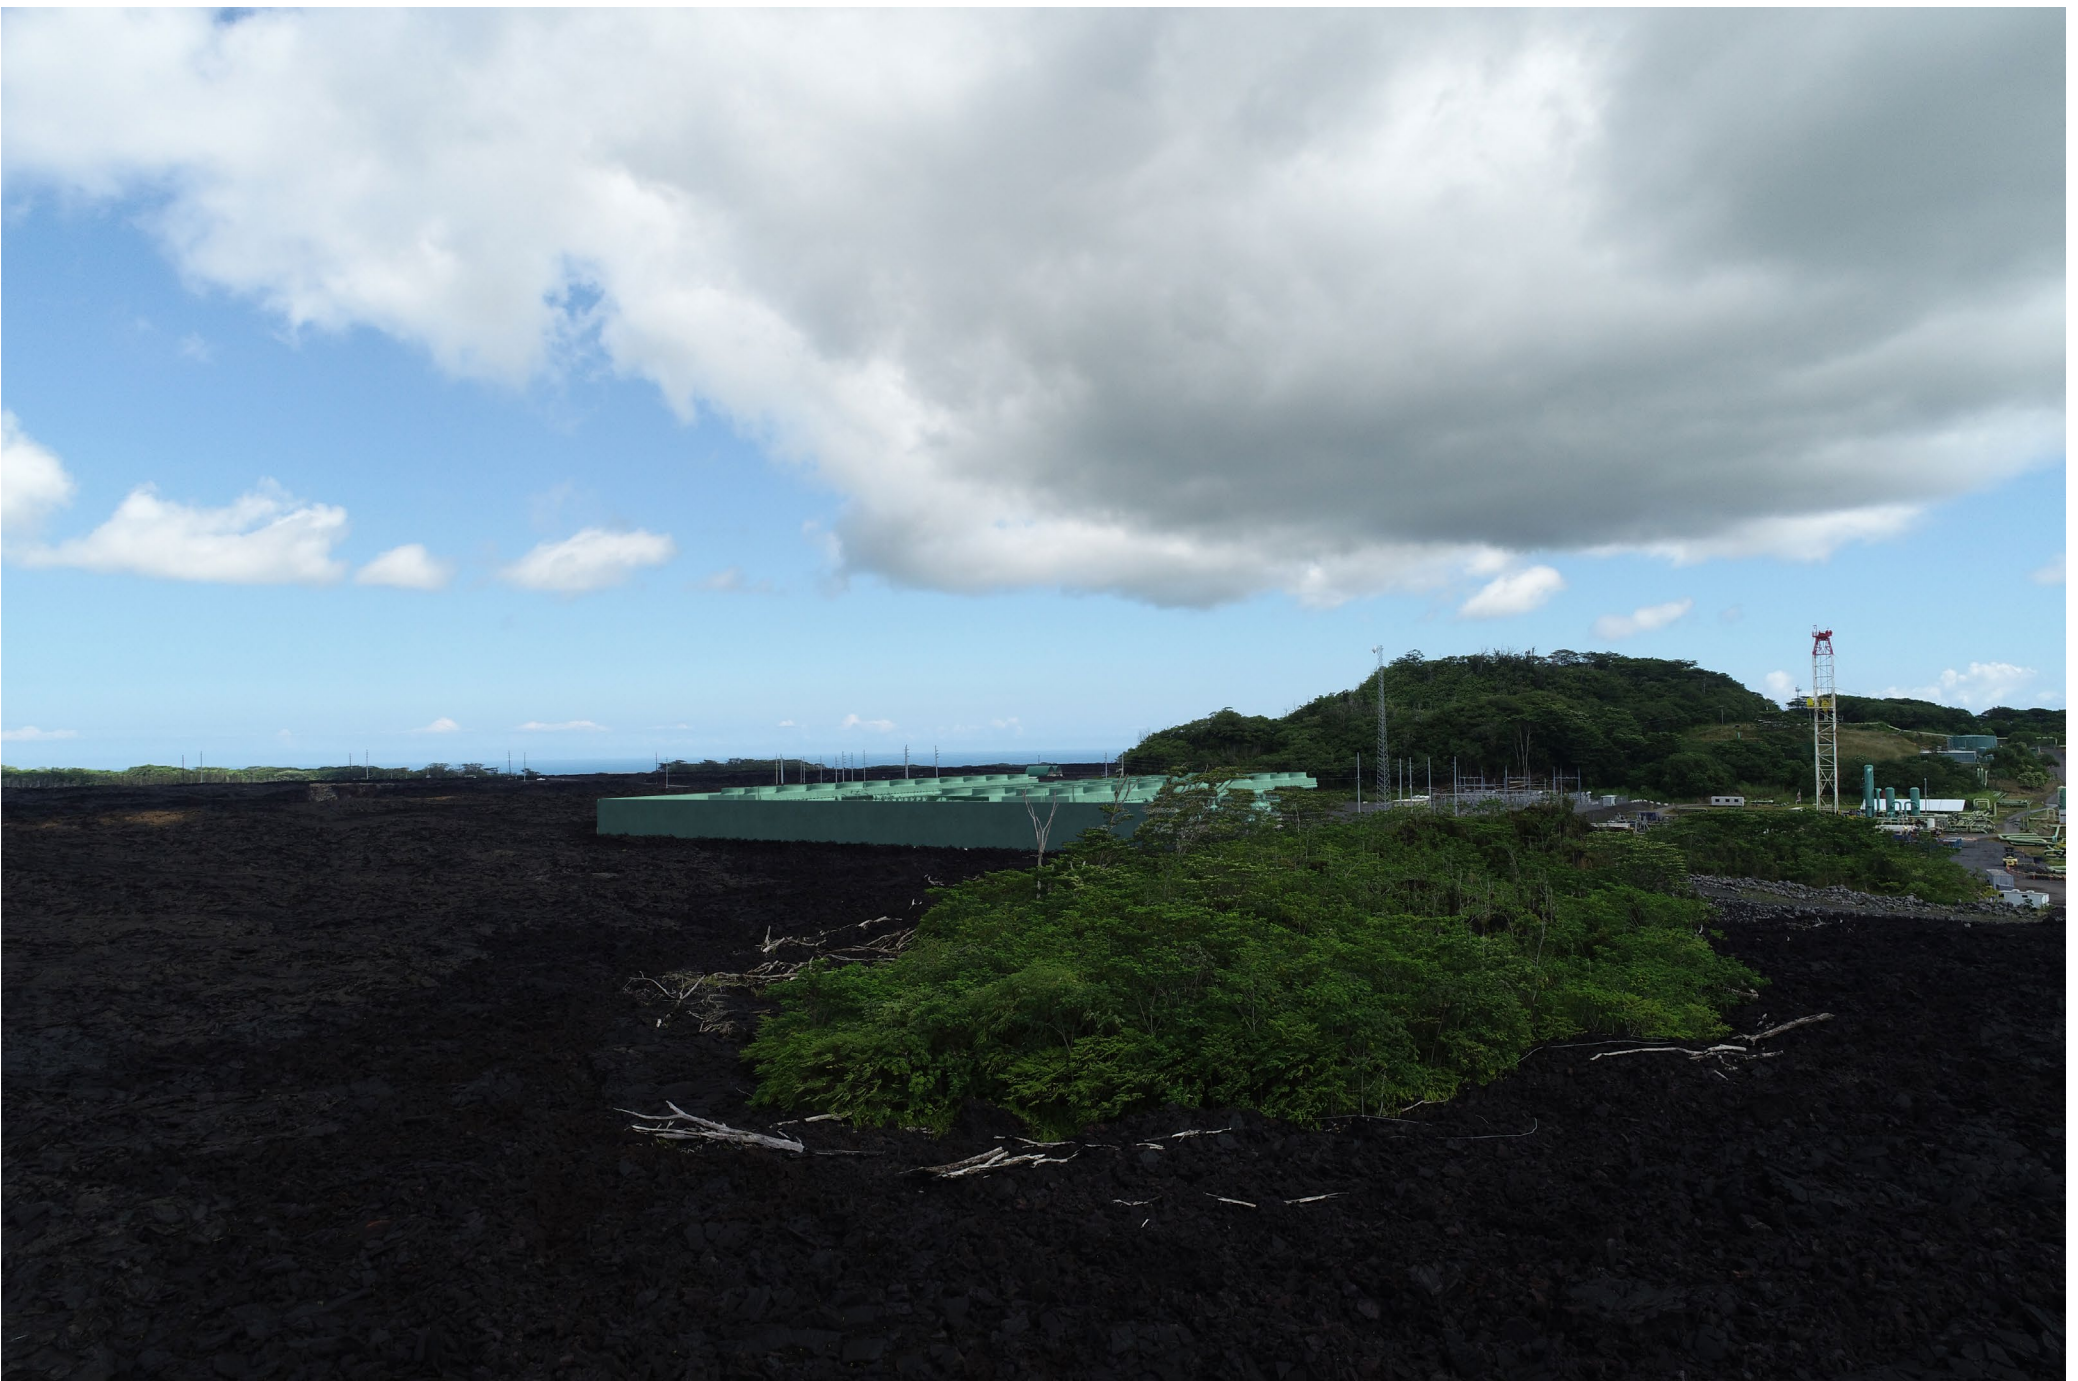
View from Viewpoint 1 with Phase 1 of the Proposed Action simulated and existing OECs removed.

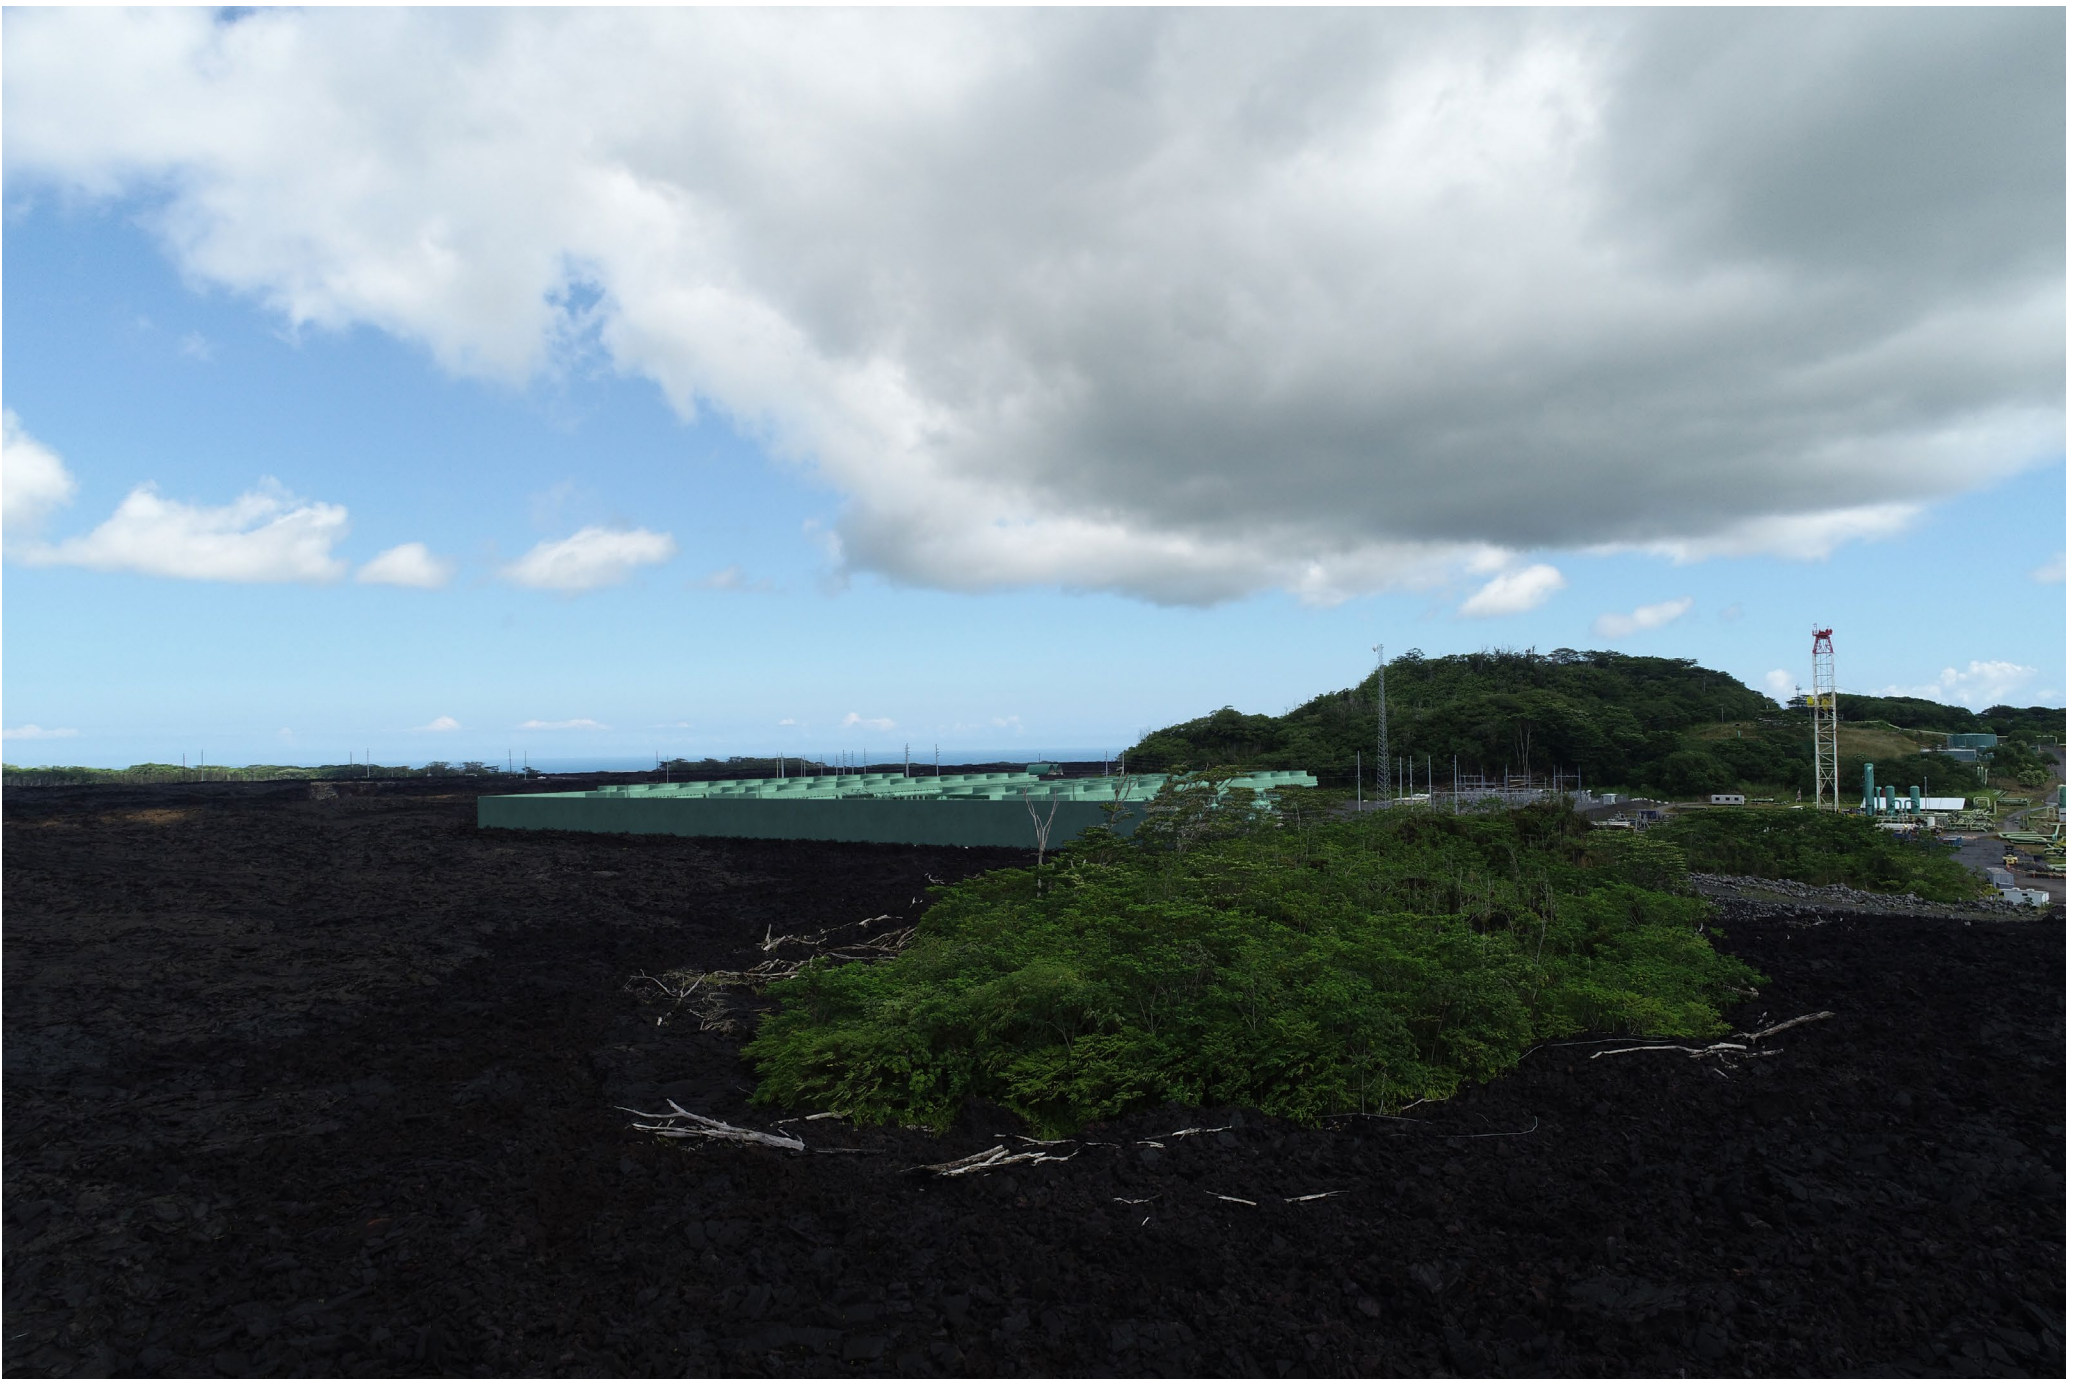
View from Viewpoint 1 with Phases 1 and 2 of the Proposed Action simulated.
